Docket No. 217 – Development and Management Plan Inspection

Date: August 12, 2004

Location: Norwalk Substation Expansion

Location: Plumtree Substation Expansion , Bethel

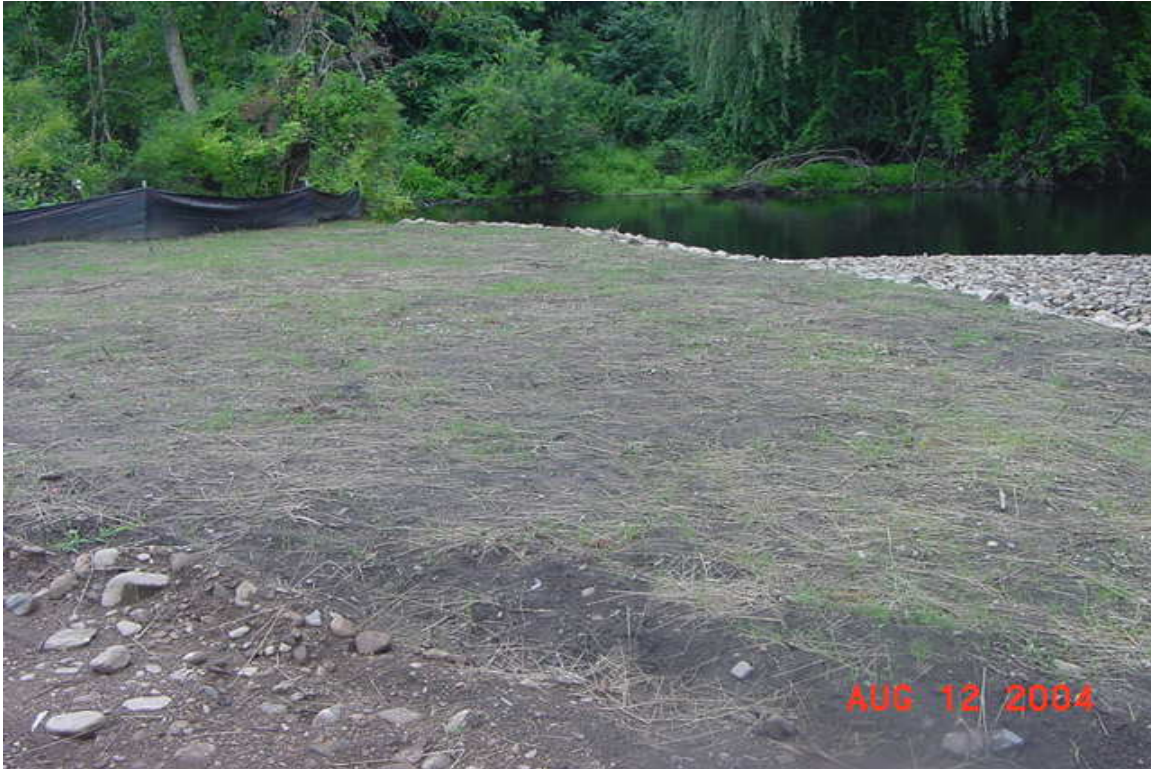
- Grass growth in some areas along the channel is still sparse. It appears that geese or other wildlife are consuming the seed before it can establish. 8/12/04	-Getting vegetation to establish here will be important before the warm growing season is over. 8/12/04 - No sedimentation or erosion was noted at the river on either end of the channel. 8/05-8/12/04
	-The seed placed on the bare spot below wall #5 is also no longer apparent and grass growth does not appear successful. 8/12/04	-Continue to monitor for sufficient vegetative growth and future stabilization. This spot could lead to a gully under the right conditions as it is in a fairly steep grade. 8/12/04
Inland Wetland and Watercourse encroachment and mitigation	<p>- The silt fence is still well in place along the river. 8/12/04</p> <p>- The areas along the channel are well under control with soil and straw mulch on the disturbed areas but additional seed may be necessary for grass cover. 8/05-8/12/04</p>	<p>- Continue to monitor silt fence and repair as necessary, especially in portions closest to the river.</p> <p>- There were no signs of sedimentation or erosion at either end of the channel. 8/12/04</p>

View of the connection to the Norwalk river at the southern end of the overflow channel. Seed is no longer apparent on bare areas which may indicate that it continues to be eaten by wildlife. 8/12/04

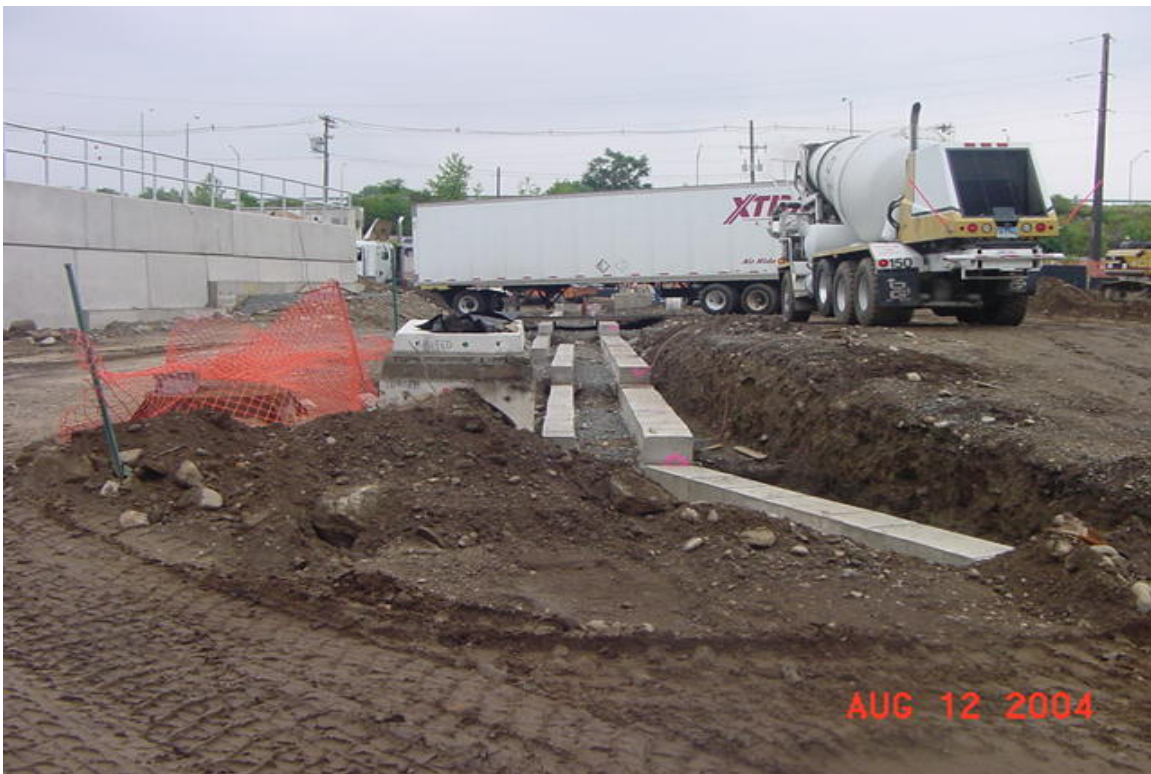
Work on the footings and construction of Wall #3 continues. The area is well contained. 8/12/04

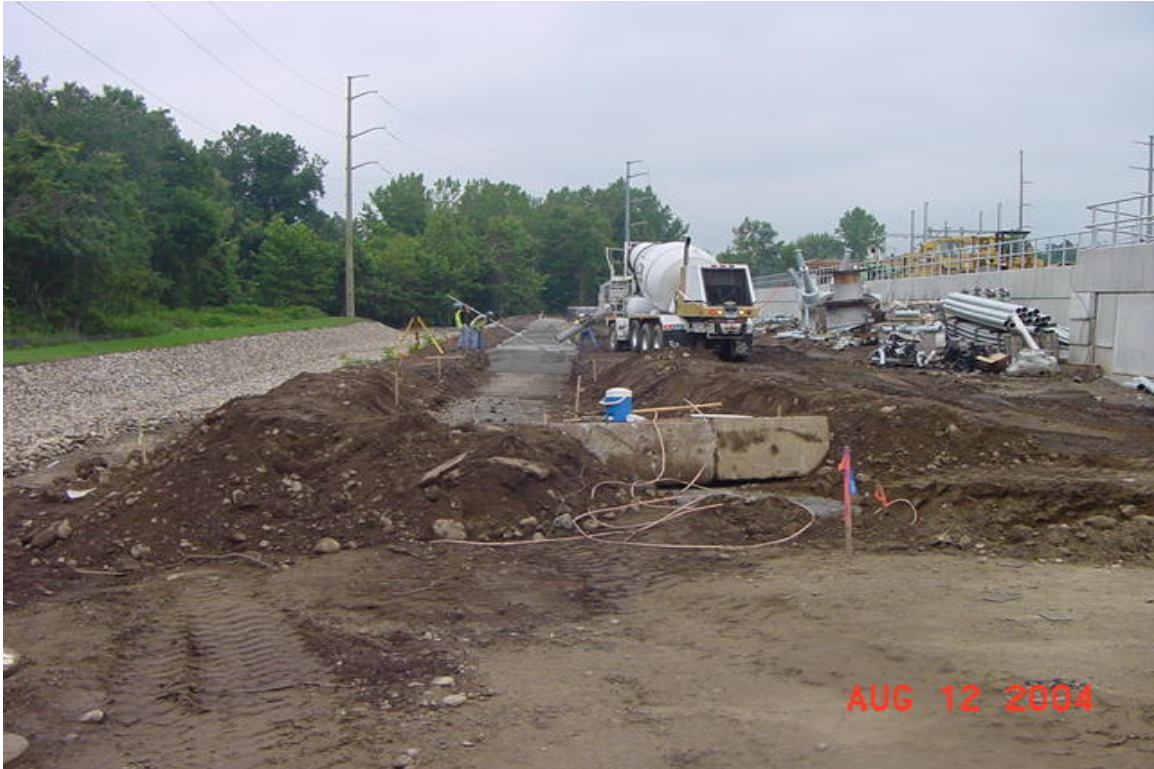
View of excavation and concrete pouring for the conduit duct banks. All areas are contained. 8/12/04

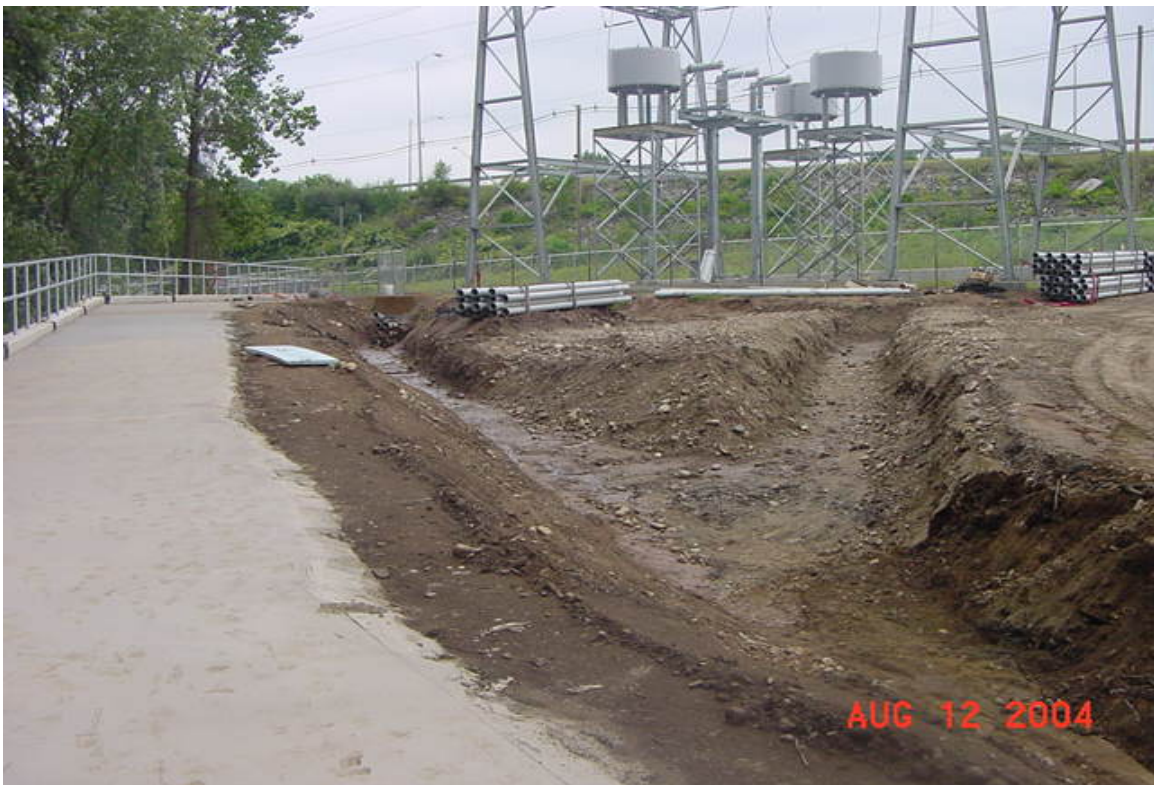
Excavations continue towards the northern portion of the site for the work on the conduits adjacent to the bike path. The excavation is contained at this time. 8/12/04

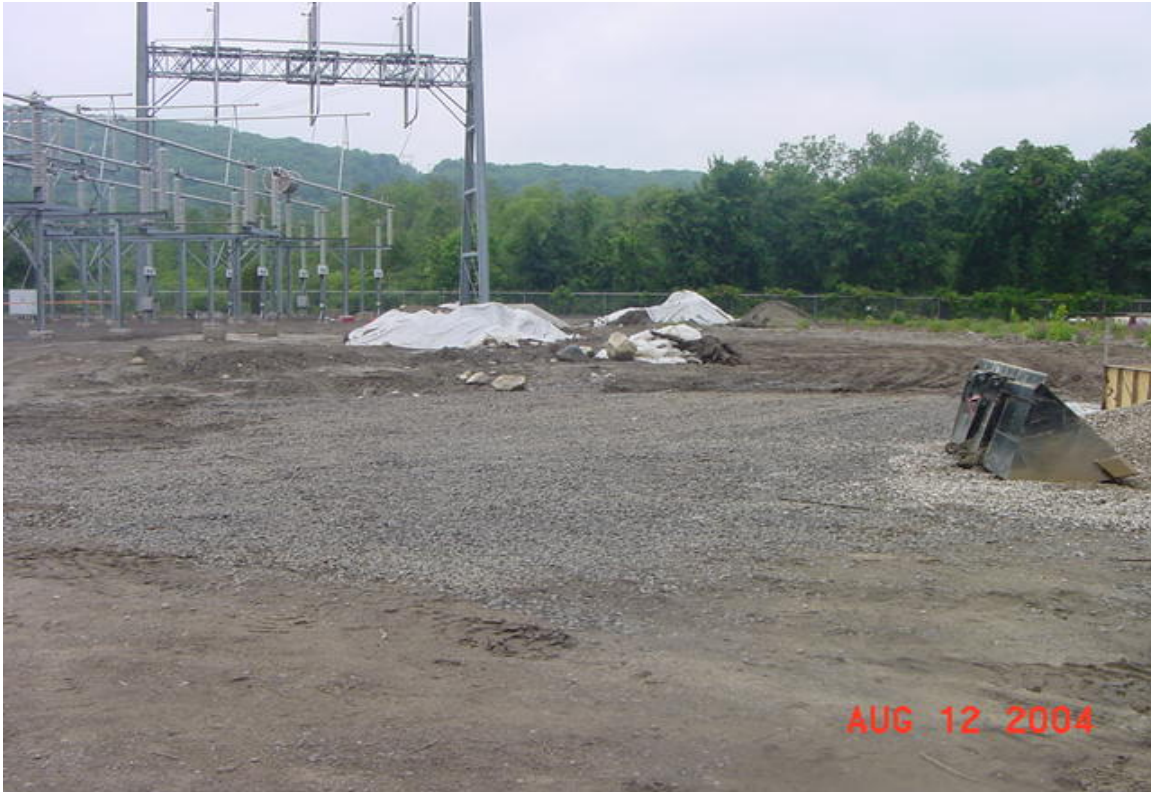
Portions of the excavations for footings at Plumtree have been backfilled and remaining stockpiles are still kept under plastic sheeting. 8/12/04

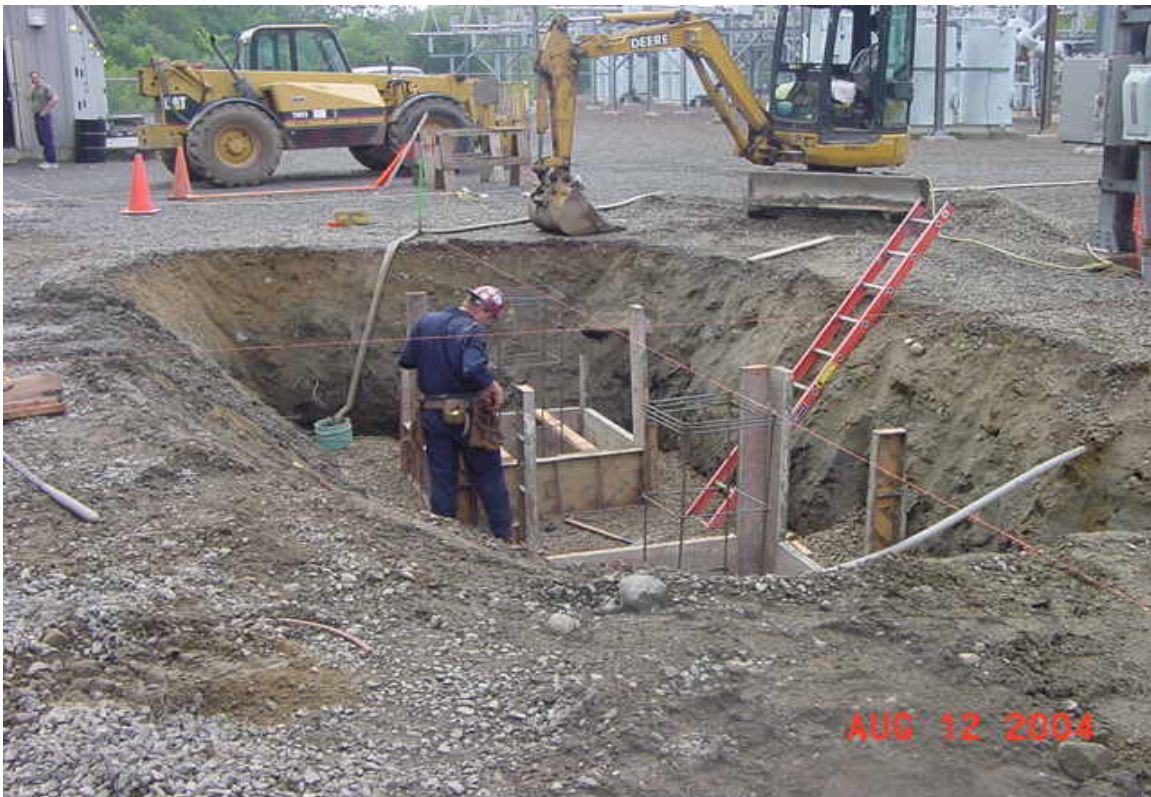
View of a new footing to be poured with the excavation well contained.. 8/12/04
